# 7750R Feed Gap Adjustment

Feed gap adjustment of the unit is always performed before shipment and optimized for US currency. However, feed gap adjustments may be required periodically. The rubber components in the feed mechanism will wear over time, causing the feed gap to get larger. This can lead to Double or Half Note errors. On the other hand, if the feed gap is adjusted to tight, this can lead to Chain error or bill jamming.

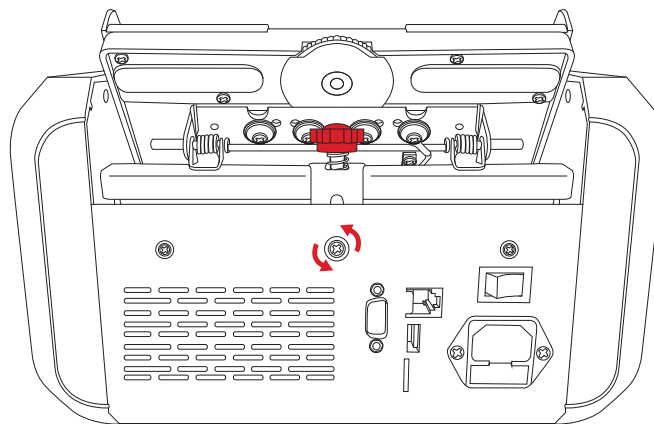
1. Ensure the machine is turned off.
2. Locate the feed gap adjustment knob (red) and the fixing plate screw (red arrows).
3. Loosen (counterclockwise) the fixing plate screw before adjusting feed gap adjustment knob.

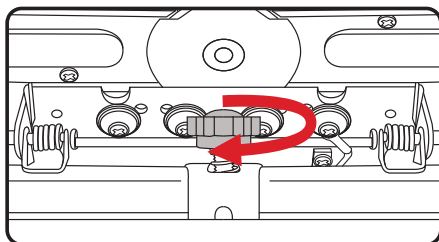
4. If more than one bill is being pulled into the feed mechanism a "Double" or "Half" Note error will appear on screen. Turn the knob clockwise to decrease the feed gap. Adjust 1 turn, then re-test the machine to see if the problem is corrected. Repeat if necessary.

If the feed gap is adjusted too narrow, Chain error, bill jams and tears can occur (see Step 5).

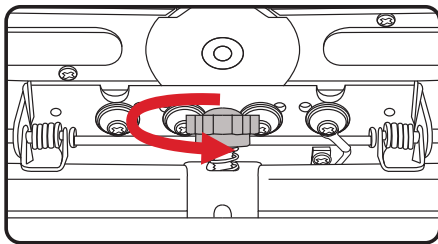
5. If the feed gap is adjusted too narrow, a "Chain" Error, or "Jam" Error will appear on screen, a narrow feed gap can also potentially tear bills. Turn the knob counterclockwise to increase the feed gap. Adjust 1 turn, then re-test the machine to see if the problem is corrected. Repeat if necessary.

If the feed gap is adjusted too wide, Double and Hall Note errors can occur (see Step 4).

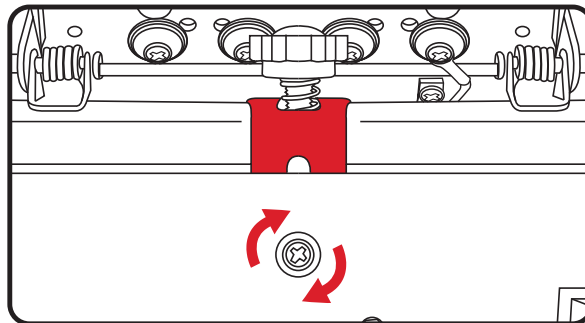
6. Secure the adjusted position by tightening (clockwise) the fixing plate screw.
